REPAIR, REHABILITATION AND RETROFITTING OF ELEVATED STORAGE RESERVOIR (ESR) SITUATED AT THANE FOR THANE MUNICIPAL CORPORATION- A CASE STUDY

Abstract—This technical paper deals with Major Repairs and Restoration of Elevated Storage Reservoirs (ESR) under Thane Municipal Corporation located at Gandhi Nagar, Thane. Being an old structure, the Elevated Storage Reservoirs faced major problems of structural distress which lead it to undergo Major repairs. Then Thane Municipal Corporation asked M/s. Supreme Engicons(India) Pvt Ltd., a leading Consulting Civil Engineering firm appointed as Structural Consultant to undertake the Major Repair and Restoration of Elevated Storage Reservoir at Thane. The structure was difficult to get accessed due to the distressed pathway to reach the area of inspection of the ESR. The condition of the structure was poor due to age factor. However, the major RCC structures were inspected with the method of visual inspection as well as Non-Destructive testing. The paper illustrates the unique methodology of Restoration on Elevated Storage Reservoirs such as Micro concreting and Fibre Wrapping work for RCC members, Internal Waterproofing of ESR and Special anti

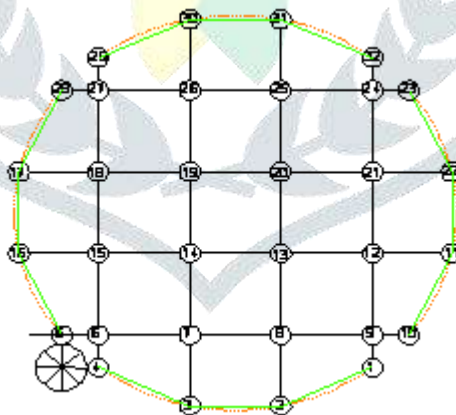
Fig.1: Representation of column supporting the ESR

The ESR is situated at Gandhi Nagar, Thane, Maharashtra. It is a RCC structure. There are 32 numbers of columns supporting the ESR and 51 beams connecting them.
