ANALYSIS OF DEFECTS IN HOT DIP GALVANIZING IN STEEL STRUCTURES

Abstract: As continuous up gradation and advancement in continuous galvanizing technology which is resulting improvements in quality of surface of hot dip galvanized and galvanized coatings, producing entirely blemish-free coatings which still stand out with challenging task. An in-depth study of these defects helps in identifying and employing prompt remedial measures to eliminate there occurrences. This paper researched by me reviews the commonly visible defects in continuously galvanized pipes products with their characteristics as studied by metallographic techniques and the means of eliminating them. Although almost every tiny defect in a galvanized coating may look like a grey spot, Less coating , ash, Black spots, peel off, lumps, Dross dimples,&Excess zincare only a small portion of the defects found in hot dip galvanized coatings. The normal size of intermetallic particles dipped in a bath < 15 µm. Such small particles are often found buried in the coating, patches of oxide skin taken up mostly on the corner of the coated strip so are not visible and distinguishable. As a matter of fact, most defects occur bec

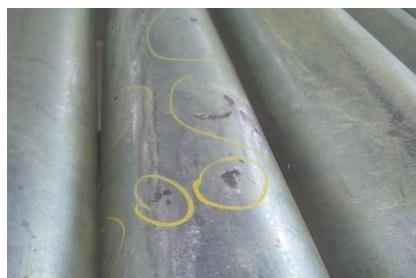
Fig-2

2.3 DARK STAINING ADJACENT TO WELDS

Preparation chemicals entering unsealed overlaps or through poor quality welds boil out of the connection during galvanising and cause surface contamination and coating misses during galvanising. Also, anhydrous fluxing salts left in the connection will absorb atmospheric moisture and leach out onto the adjacent galvanised surface. Leaching of these salts will eventually reach equilibrium. Affected areas should be washed clean to remove slightly corrosive leachate.

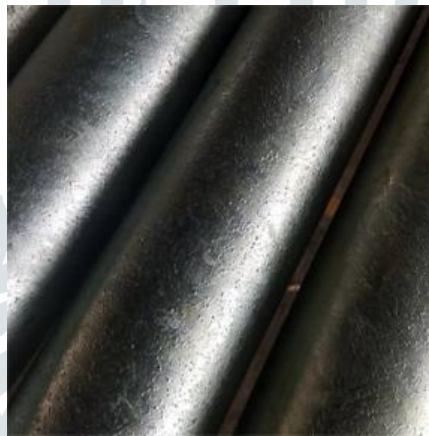
Fig-3

2.4 DROSS PIMPLES/INCLUSIONS

Dross is formed in the galvanising process in the form of zinc-iron crystals (approx 95% zinc – 5% iron) with a higher melting point than the metal in the zinc bath. Dross trapped in the galvanised coating may give the coating a rough or gritty appearance. The presence of dross inclusions in the coatings is not detrimental to the coating's performance as the corrosion resistance of zinc dross is identical to that of the galvanising coating.

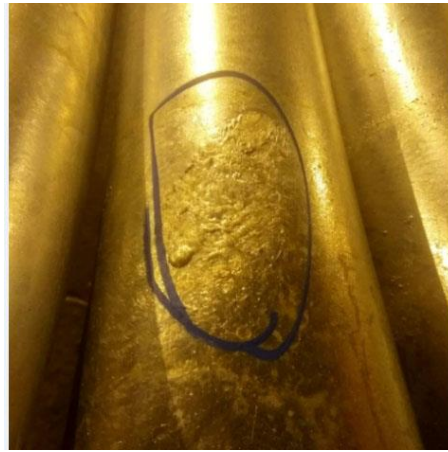
**Fig-4**

3. SPANGLED COATINGS

Some hot-dip galvanised coatings exhibit a high level of 'spangling' caused by zinc crystal patterns on the surface. This phenomenon arises with galvanising alloys produced in particular smelting processes and these alloys are commonly used for hot-dip galvanising. There is no difference in coating performance.

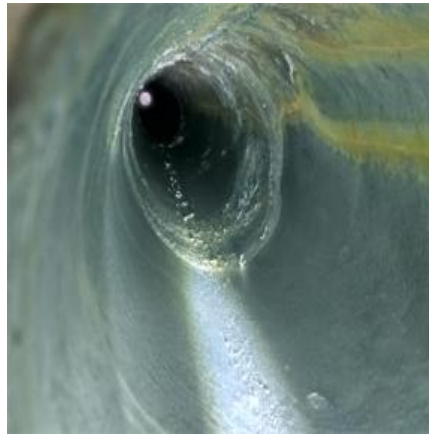
**Fig-6**

6. ASH STAINING

Zinc ash is formed in the galvanising process as the work is immersed in the zinc. The ash formed is skimmed off the surface of the molten zinc prior to withdrawing the work from the galvanising bath. Sometimes, ash is trapped inside inaccessible areas and sticks to the outside of the coating as the work exits the bath. Ash may leave a dull surface appearance or a light brown stain after removal. It does not affect the performance of the galvanising coating.

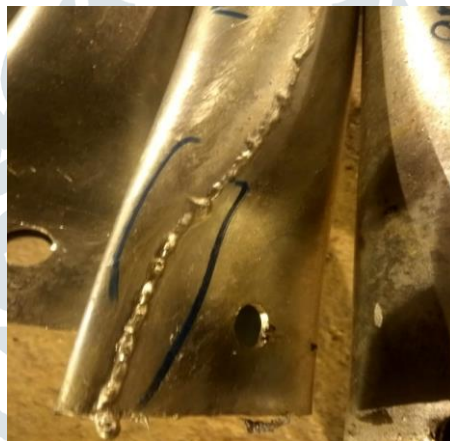
**Fig-7**

7. RUNS, DRAINAGE SPIKES AND PUDDLING

These defects are unavoidable in the hot-dip galvanising of general items and are acceptable as long as they do not interfere with the assembly of the function of the item or present a safety hazard in handling or service.
