# Study of Silt Erosion Mechanism in Pelton Turbine Buckets

**ABSTRACT:** An experiment was carried out in order to explore the mechanism of erosion of a small size Pelton turbine under actual flow conditions in the current study. Silt samples were taken from the head works of one of India's most silt-affected hydropower plants. The process of silt erosion on Pelton turbine buckets for different silt sizes was investigated using silt parameters (silt particle size and silt concentration). Hot areas were discovered in the initial half of the experiment when the silt content was high. The second phase of the experiment involved studying the erosion mechanism for tiny metal specimens that were fixed to the hot areas. According to the findings, silt size is a significant factor in erosion, and material removal from the surface is caused by plastic deformation and ploughing of the surface. Examination of different explanations for the decreased performance and efficiency of hydro turbines owing to silt erosions, as well as appropriate corrective techniques for such erosion offered by various scientists.

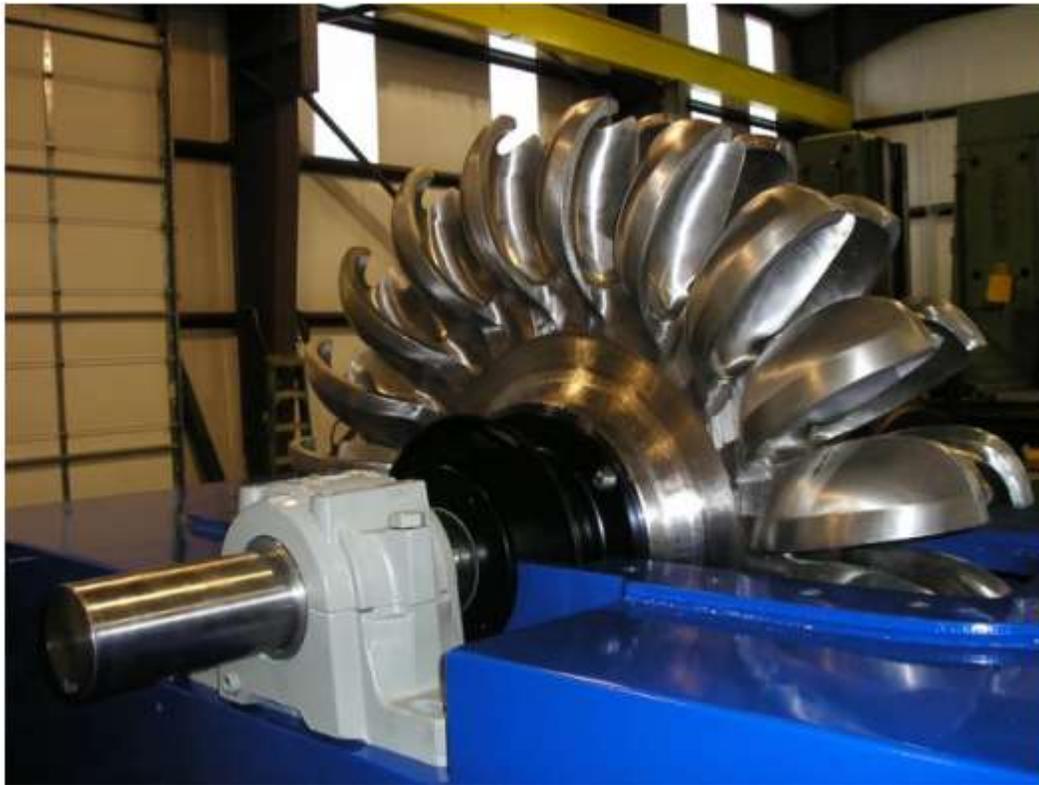
surface. When both wear mechanisms are involved, material loss is quicker. Fig. 1, Illustrates the pelton wheel turbine used to convert hydraulic energy in to kinetic energy.

**Fig. 1: Illustrates the pelton wheel turbine used to convert hydraulic energy in to kinetic energy.**

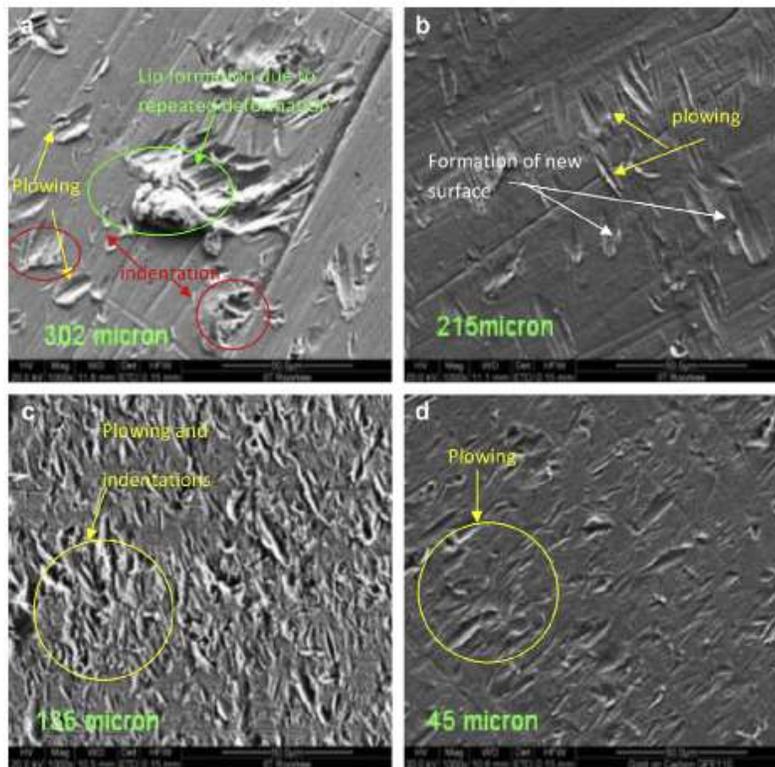
**Fig. 2: Illustrates the erosion over plate of the Pelton wheel turbine at micro level [9].**

Fig. 2, Illustrates the erosion over plate of the pelton wheel turbine at micro level the silt water combination was supplied to the turbine by a centrifugal pump. Before hitting, the silt water combination was pushed via a nozzle by the turbine bucket. To convert the hydro potential head to a velocity head, the nozzle was attached to the end of the penstock. The pressure head at the turbine's intake was measured using a digital pressure transducer. A control valve attached to the centrifugal pump's output maintained a constant pressure head. Water was permitted to flow back to the water tank from the turbine output. To apply the electrical load, a generator was directly connected to the runner shaft. The severely eroded portions hot spots on the Pelton turbine bucket were discovered in order to examine the mechanism of erosion in different sections of the turbine bucket. To avoid hot spots in a shorter duration of turbine operation, a coating of readily worn out material was applied to the bucket surface. A thin coating of nickel was applied to the surface. The silt and water combination was made with a 5% weight concentration of silt. The fine form of silt molecules will cause erosion in the region of the pointer, but not enough in the buckets. When contrasted to needles, coarse particles will substantially damage the buckets. The silt pieces' intermediate size will erode the needle as well as the buckets. In terms of increasing the applied magnitude, the multi-scale replica is a brave step. Fig. 3, Illustrates the particle separation at high speed of jet coming on plate.

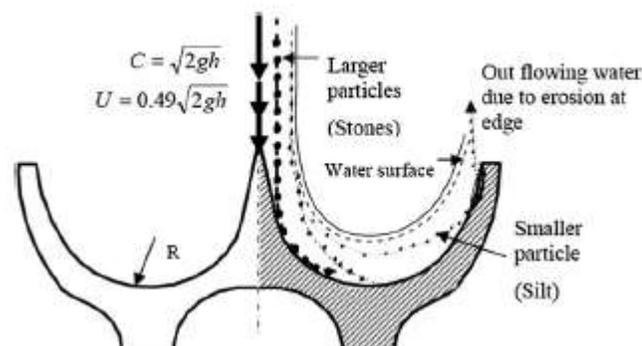
**Fig. 3: Illustrates the particle separation at high speed of jet coming on plate [10].**
