Multistoried Building subjected to Multiple Hazards Simultaneously and Preventive Measures

Dr. Nilesh S. Jha

Faculty, Civil Engineering Department, Government Polytechnic, Ahmedabad

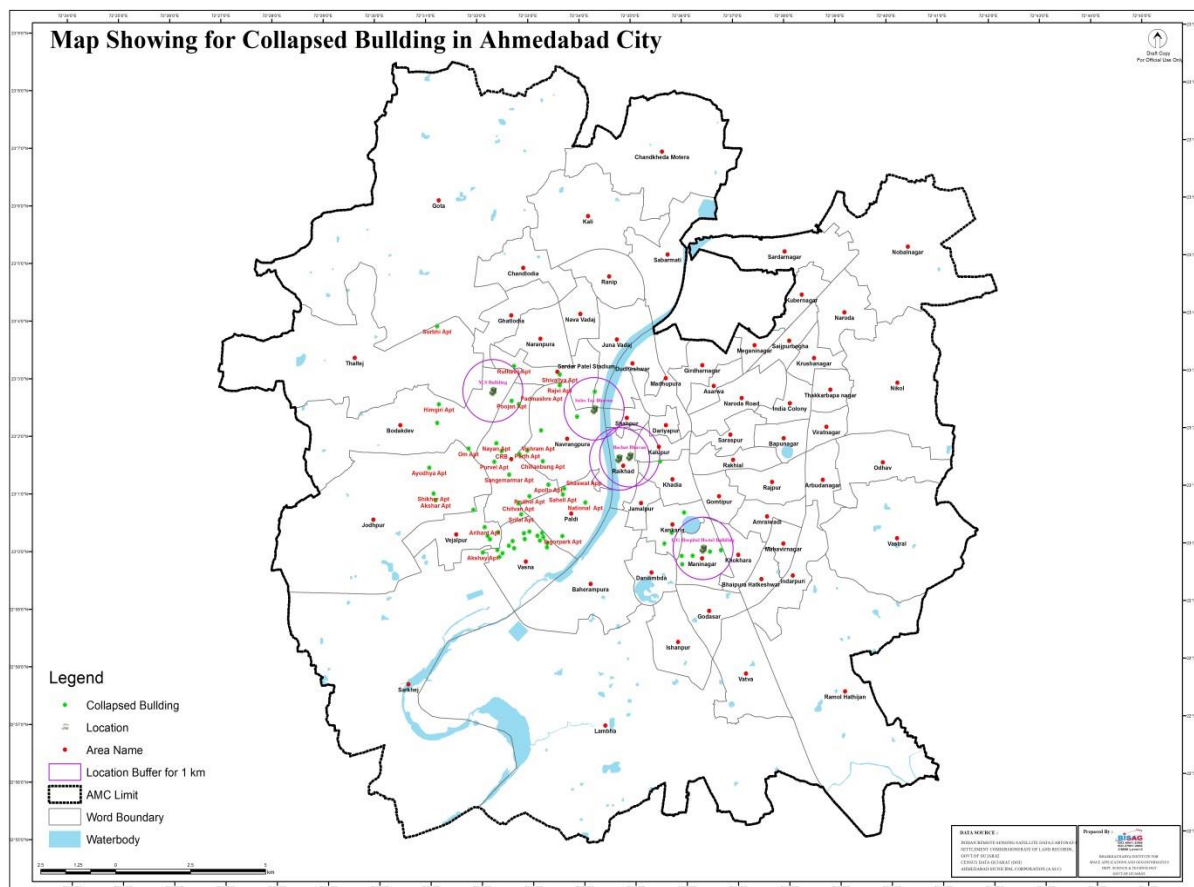
MAP – 1: Location of Collapsed multi-storied buildings in Ahmedabad

Locations of 58 out of the approximately 130 buildings that collapsed in Ahmedabad are shown in Map - 1.
