# RESPONSE CHARACTERISTICS OF STRUCTURES HAVING IRREGULARITY SUBJECTED TO VERTICAL EXCITATIONS

NISHANT LAXMIKANT AGRAWAL

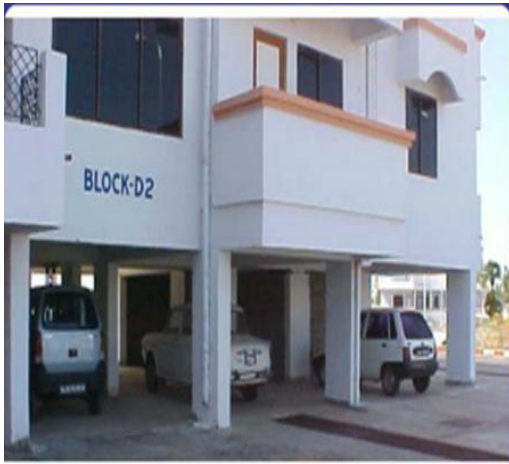
Figure 1 Vertically irregular OGS (Open Ground Storey) building    Figure 2 Vertically irregular Stepped Typed Building

1. OGS (open ground storey) building:- In this structure the ground storey is kept open for the use of parking i.e no walls are been provided at this level of the structure, thus irregularity is been induced making the structure less stiff. Due to the lack of the infill walls in the ground storey which of existing at the storey above, the stiffness is abrupt decreases that are called as stiffness irregularity. The base shear is registered through the ground storey columns. Due to the increased the shear pressure will cause the increased bending moment and thereby greater curvature which may possibly will higher inter storey drift formation at the ground storey which enhance by the  $P\Delta$  effect the plastic hinges are formed. Top of the shop will go as one block. This kind of collapse is called as smooth storey collapse. Due to the reduction in the stiffness at ground storey this particular kind of buildings are viewed as probably the most susceptible sort through the seismic point of view. The fig reveals the soft storey collapse of typical OGS structures.

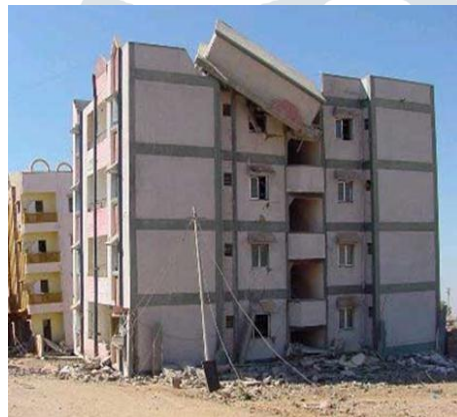
Figure 3 Failure of OGS buildings in bhuj earthquake (ref : [www.nicee.org](http://www.nicee.org))

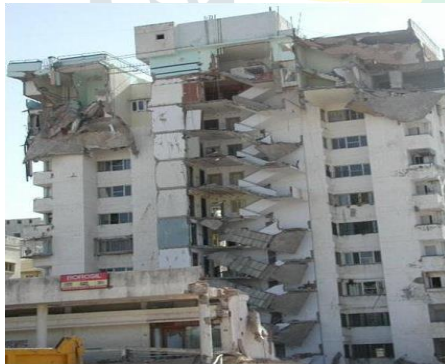
Figure 4 Failure of OGS buildings in bhuj earthquake (ref : [www.nicee.org](http://www.nicee.org))

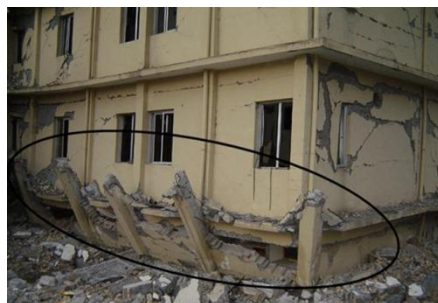
Figure 5 Shear failure of ground storey columns (ref : world housing encyclopedia eeri & aiee)

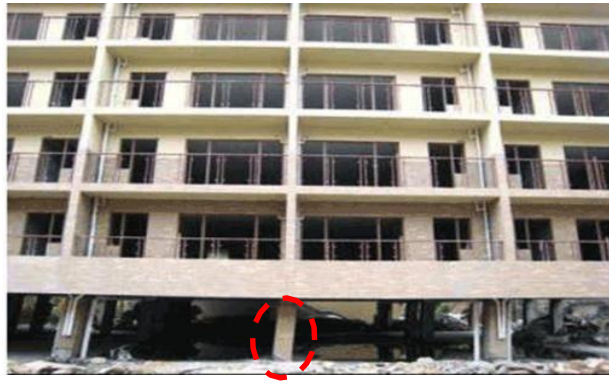
Figure 6 Plastic hinged formation at column ends of the ground storey columns in China Earthquake 2008

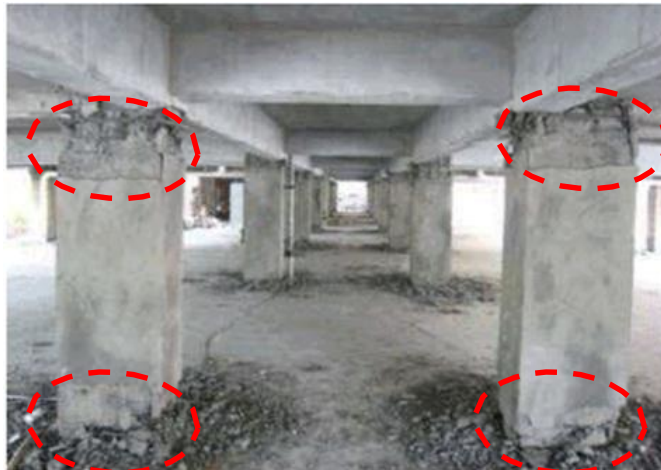
Figure 7 Plastic hinged formation at column ends of the ground storey columns in China Earthquake 2008
