STUDY ON THE WATER CHEMISTRY OF CHIKKABANAVARA LAKE, BANGALORE URBAN DISTRICT, KARNATAKA, INDIA

Abstract: Chikkabanavara lake is a naturally formed lake which is located at a distance of 1.5 km north of Chikkabanavara Railway Station along Bangalore – Tumkur railway line, situated between Chikkabanavara and Kereguddadahalli village, It lies between Lat. 13° 08'N and longitude of 77° 50'E. The lake is accessible by Hesaraghatta Road from 8th mile (T. Dasarahalli) junction on the Bangalore –Tumkur National Highway (NH4). The total extent of the lake is 105 acres and 15 guntas (according to Bangalore Development Authority (BDA) records. This lake is situated outside BBMP area coming under the custody of BDA North Division. The Chikkabanavara lake gets water from rain fall having catchment in nearby chimney hills due to the topography of land the natural in flow runoff water reaches the lake from all the sides of lake. Due urbanisation in recent years the lake is not able to get the rainwater as most of the natural drains were disturbed, instead the lake is collecting municipal and industrial waste water. In the present study chemical parameters of the lake water has been done and to

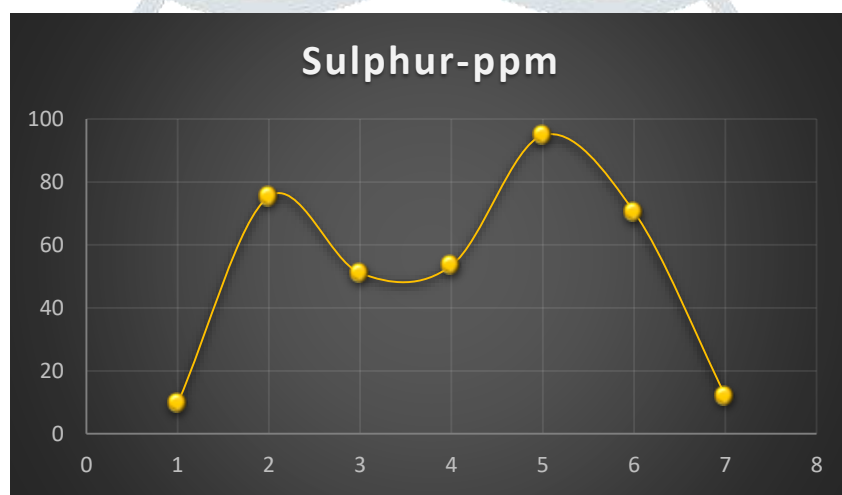
Fig. 4: Variation of Sulphur

Sulphur occurs in water as sulphate and sulphides. Sulphates of evaporates and those produced from the weathering of sulphides are the source of soluble sulphates in groundwater. But in the present study the reason for concentration of sulphur may be due to the industrial waste water directly disposed to the lake. The maximum concentration of sulphur in the water samples collected from the lake is 94.78 ppm and minimum of 51.04 ppm (Fig. 4).

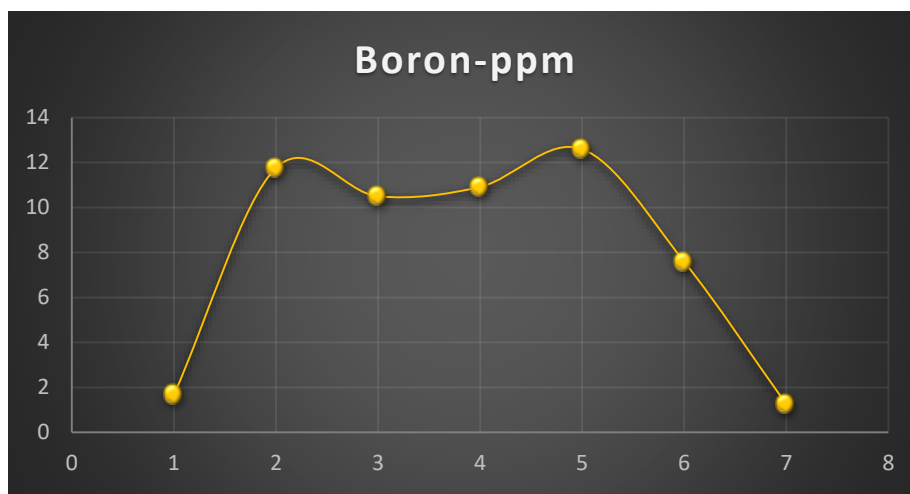
Fig. 5: Variation of Boron

Waterborne boron may be adsorbed by soils and sediments. Adsorption-desorption reactions are expected to be the only significant mechanism influencing the fate of boron in water. The extent of boron adsorption depends on the pH of the water and the concentration of boron in solution. The greatest adsorption is generally observed at pH 7.5–9.0. In the present study the maximum concentration observed is 12.60 ppm and minimum is 7.56 ppm (Fig. 5).
