Application of Micro Concrete for Repair of Concrete Pavement - A Case Study.

Case Study

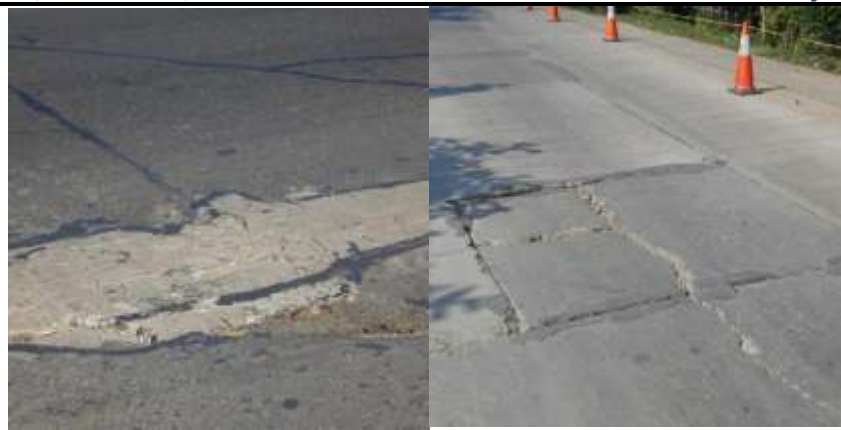
In India, new roads are being constructed rapidly and existing arteries are increasingly being expanded^[5]. However, once roads are built, they often undergo structural damages. The roads in metro cities such as Mumbai, Delhi, Kolkata, etc. carries heavy traffic and a high volume of vehicles. Contours of the highway that climb sharply and turn abruptly, combined with unstable base soil factors and high amounts of rainfall, result in rapid erosion and other soil issues that cause damage to the road bed and pavement surfaces, including collapsing, pumping, and spalling, as illustrated in the following figures^[5].

Fig 1. (a-b): Damage to the concrete pavement

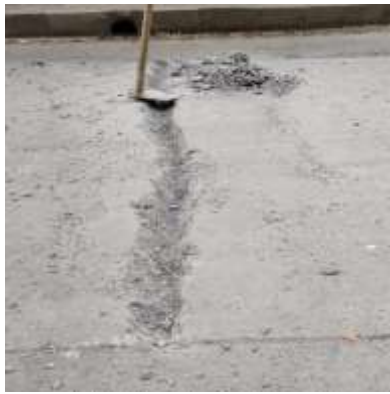
**Fig 01:** Making the groove

The Crack which was developed has been opened properly by cutting the V shaped grove so that the repair work to be carried out would result in a good way.

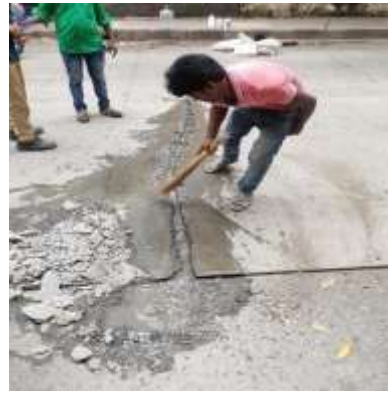
**Fig 02:** Cleaning the application surface

The grooved surface was then prepared before the application of micro concrete by removing oil, bond inhibiting agents, dirt, dust and laitance. The cleaning can be carried out with suitable methods like using wire brush, water jetting, mopping, etc.

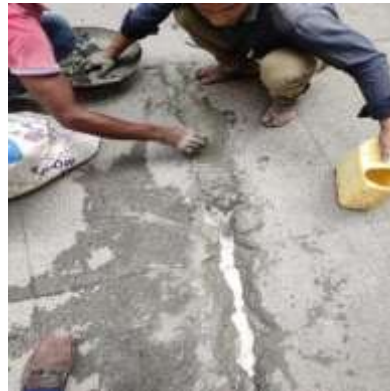
**Fig 03:** Mixing the contents

All the ingredients as per mix proportion was then mixed to the measured quantity of water with constant stirring. It was mixed to a thick lump free consistency and allowed to stand for 2 minutes for the mix to mature and then remixed to use.

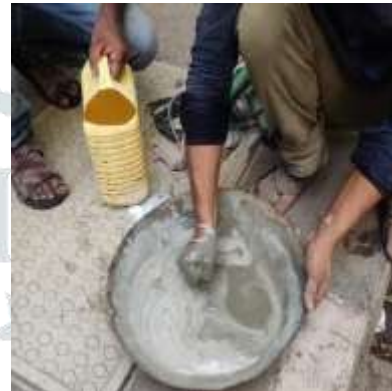
**Fig 04:** Application of material prepared**Step 1: Surface preparation:**

The mixed material was applied to the prepared substrate using the appropriate pouring funnels and chutes. It should not be vibrated with any mechanical vibrators as it is self-compacting by itself and any external vibration would segregate the mix.
